SITE ASSESSMENT

CHICAGO INDUSTRIAL WASTE HAULERS
ALSIP, ILLINOIS

TAT-05-G2-01019

May 1989

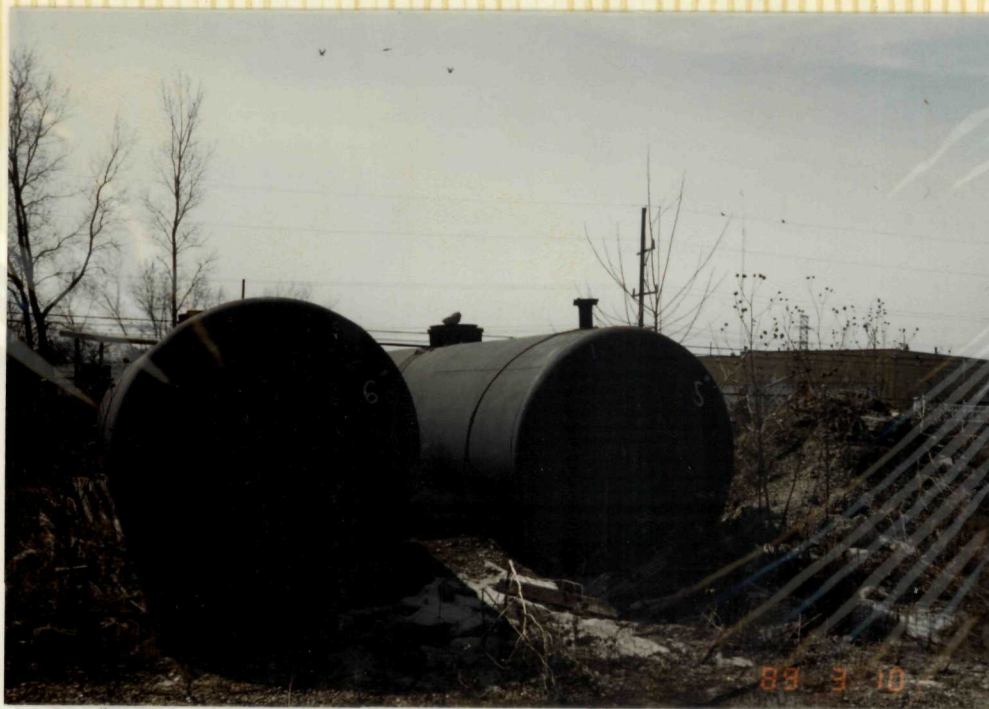
Photograph #1
 Chicago Industrial Waste Haulers. Alsip, Illinois
 View of tanks on the south side of the site. Looking southwest.
 Date: 3-10-89 Time: 1145
 Photographer: Paul Szewczykowsk *P.S.*
 Camera/Film: 35mm/ 200 ASA

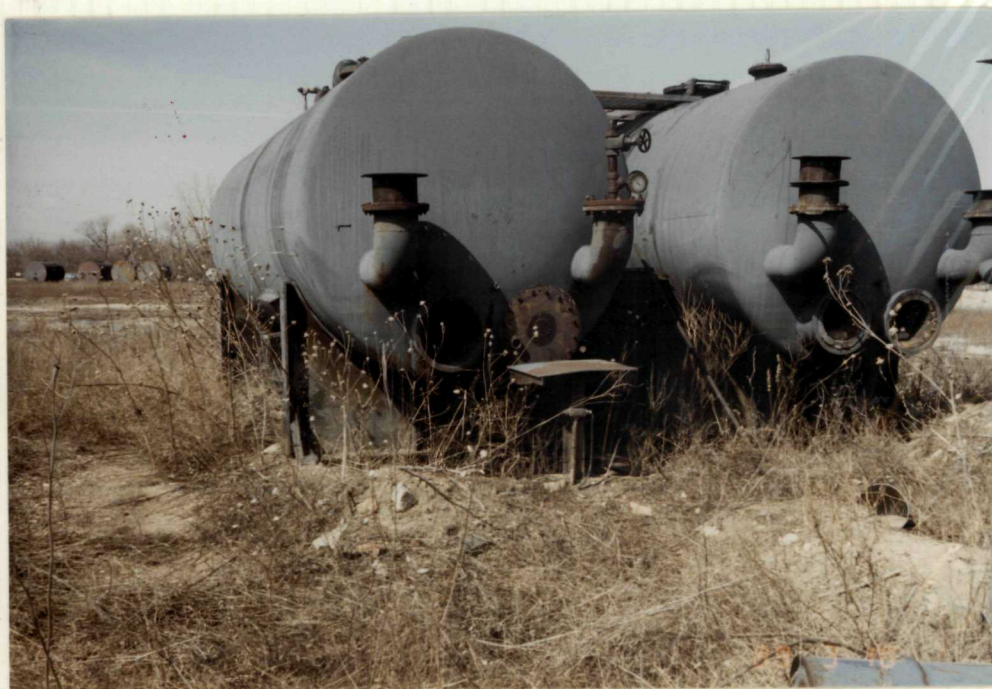
Photograph #2
 Chicago Industrial Waste Haulers. Alsip, Illinois
 View of tanks on the south side of the site. Looking northwest.
 Date: 3-10-89 Time: 1200
 Photographer: Paul Szewczykowsk *P.S.*
 Camera/Film: 35mm/ 200 ASA

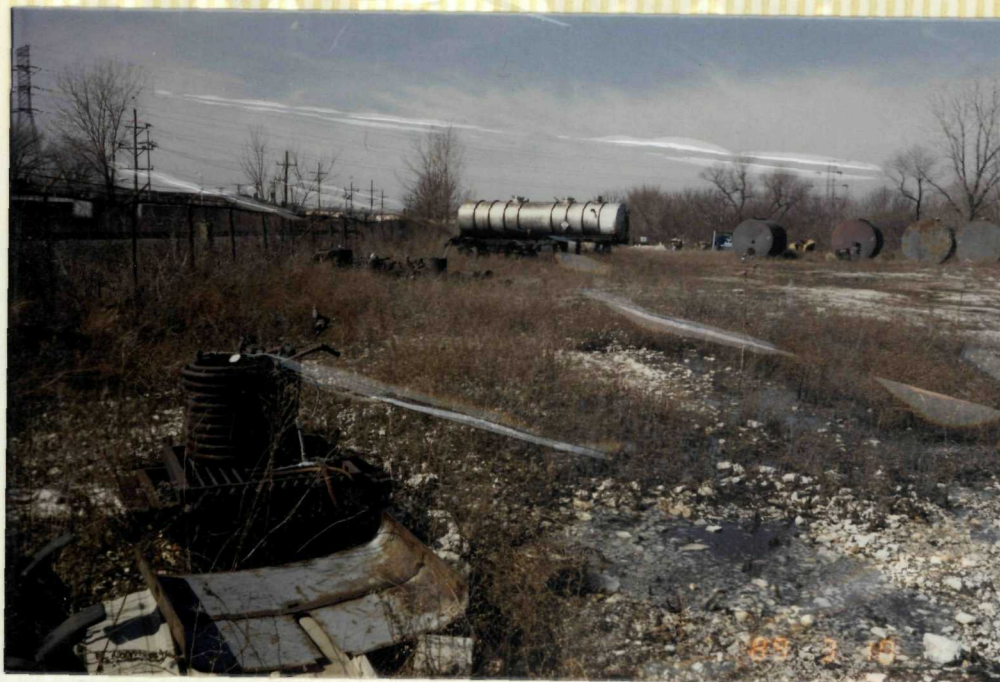
Photograph #3
 Chicago Industrial Waste Haulers. Alsip, Illinois
 View of truck tanker and oil tanks near west border of
 site; looking northwest.
 Date: 3-10-89 Time: 1210
 Photographer: Paul Szewczykowski P.S.
 Camera/Film: 35mm/ 200 ASA

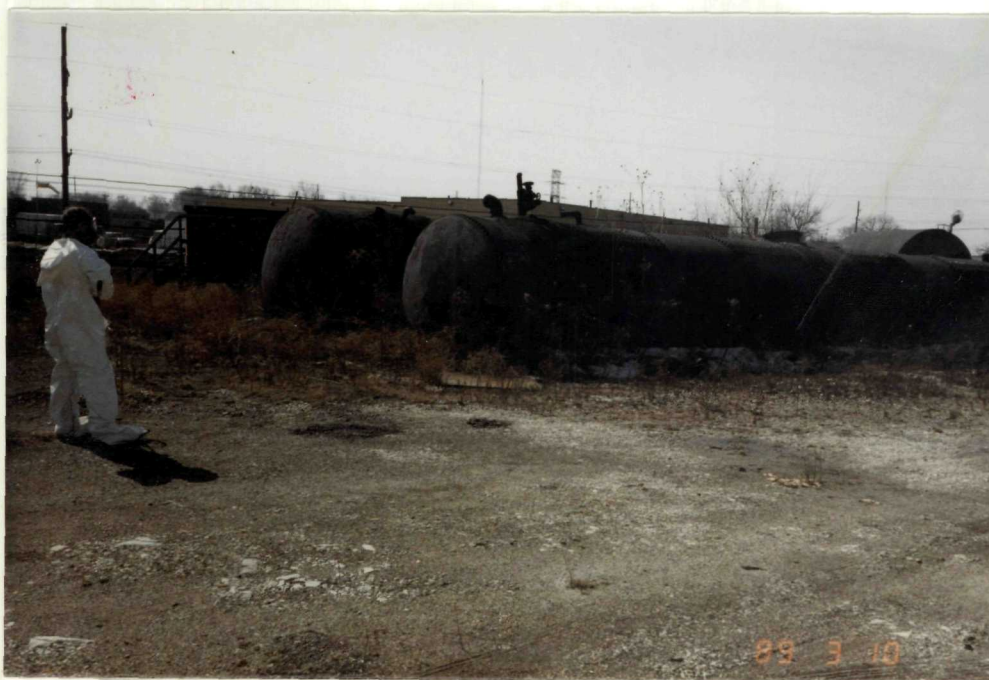
Photograph #4
 Chicago Industrial Waste Haulers. Alsip, Illinois
 View of tanks near south border; looking southwest.
 Date: 3-10-89 Time: 1215
 Photographer: Paul Szewczykowski P.S.
 Camera/Film: 35mm/ 200 ASA

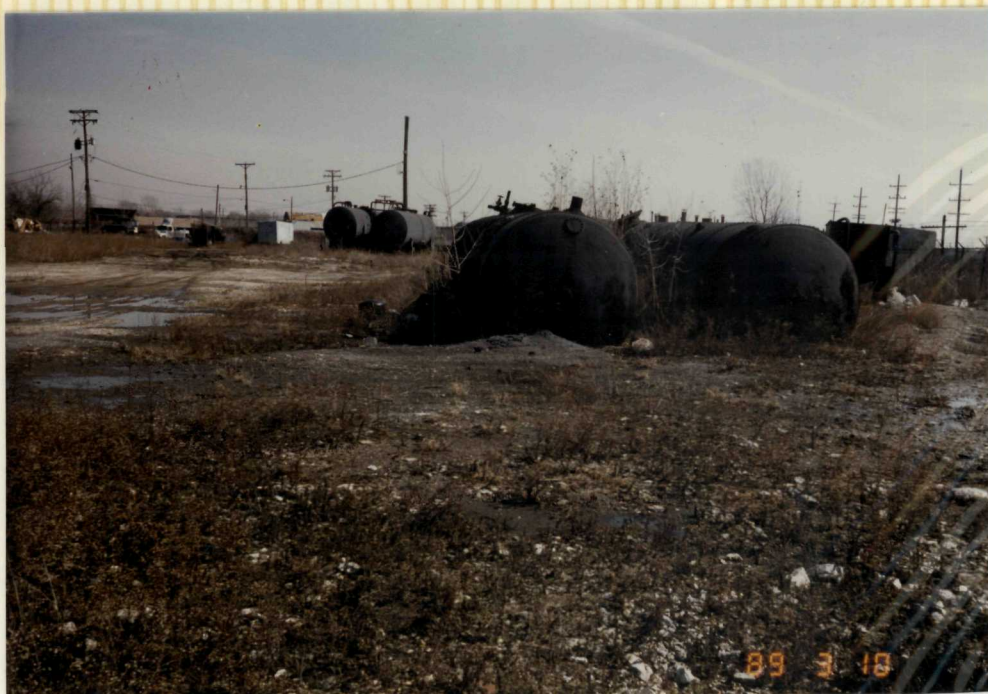
Over twenty-four tanks were observed on site. Many of these tanks had open lids and vent pipes which could allow rainwater to enter and overflow hazardous materials to enter onto the ground. The tanks have no secondary containment structures which could contain the contents in the event of a release. The discoloration of the soil near several tanks indicates past releases.

Photograph #5
 Chicago Industrial Waste Haulers. Alsip, Illinois
 View of tanks on site; looking east.
 Date: 3-10-89 Time: 1230
 Photographer: Paul Szewczykowsk *P.S.*
 Camera/Film: 35mm/ 200 ASA

- o Sampling of all tanks at the facility for disposal parameters could be conducted and the contents disposed of consistent with RCRA compliance. The tanks could be dismantled, rendering them incapable of holding materials, or removed from the site.

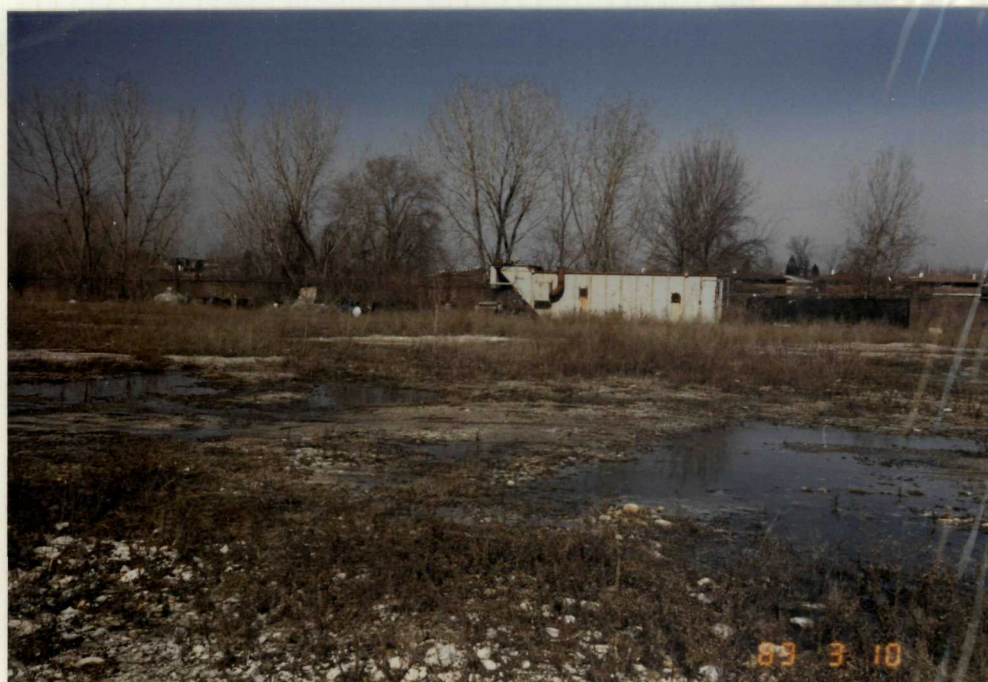
Photograph #6
 Chicago Industrial Waste Haulers. Alsip, Illinois
 View of tank along the north border of the site;
 looking north.
 Date: 3-10-89 Time: 1300
 Photographer: Paul Szewczykowsk *P.S.*
 Camera/Film: 35mm/ 200 ASA

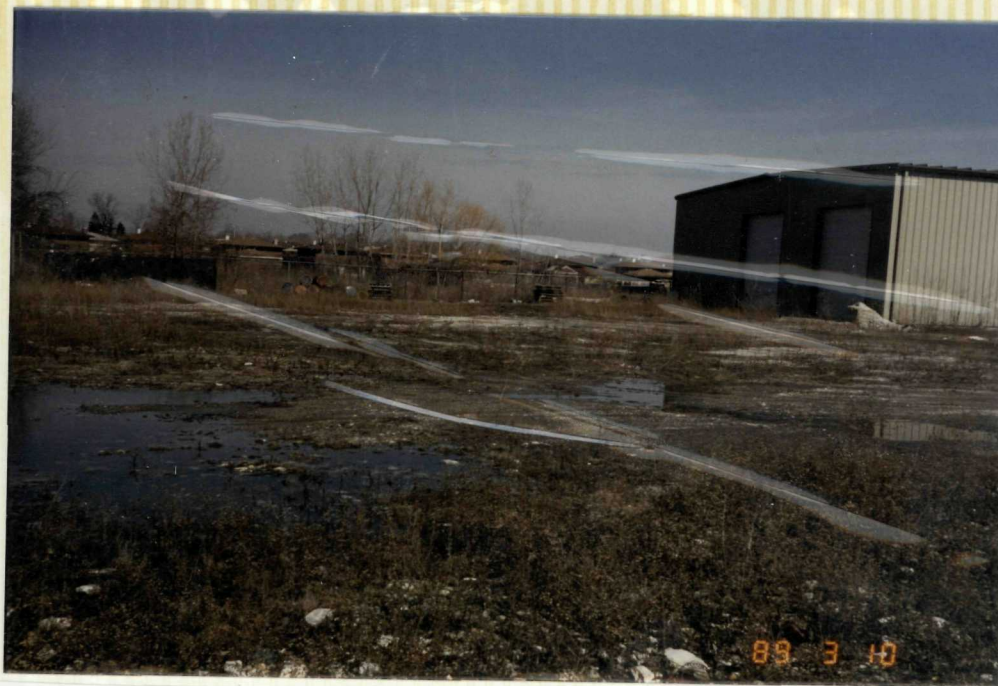
Photograph #7
 Chicago Industrial Waste Haulers. Alsip, Illinois
 View of tank and drums along the northern border of the site;
 looking north.
 Date: 3-10-89 Time: 1315
 Photographer: Paul Szewczykowski P.S.
 Camera/Film: 35mm/ 200 ASA

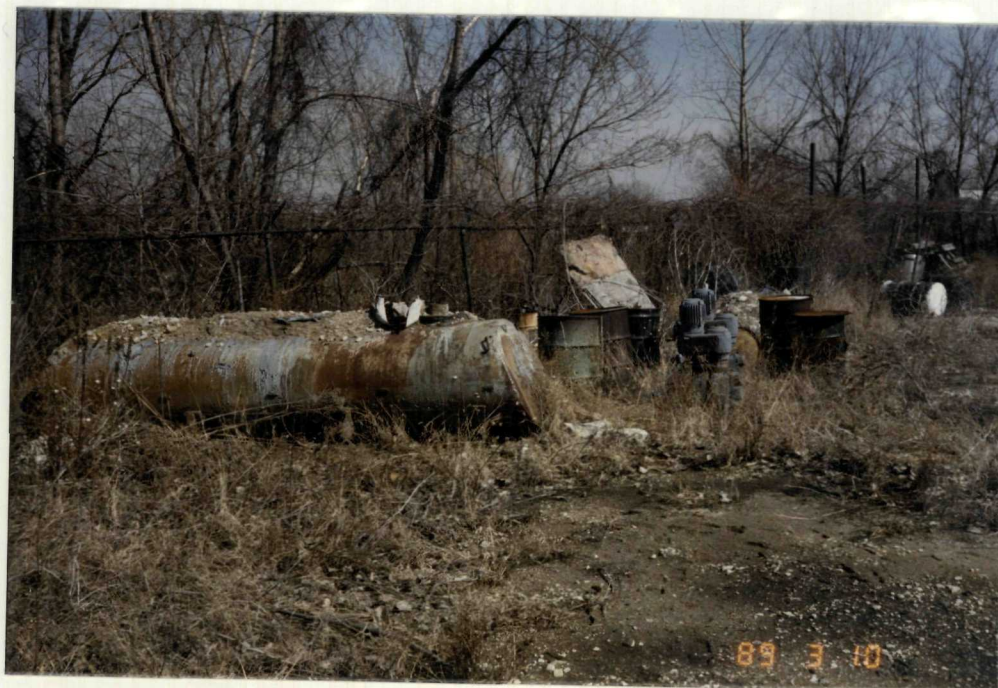
On March 10, 1989, the Technical Assistance Team (TAT) conducted a spill prevention control and countermeasure (SPCC) inspection at the CIWH site. Air monitoring was conducted with an organic vapor analyzer (OVA) and readings of 3.5 units and 65 units over background were recorded near two tanks on the site.

Photograph #8
 Chicago Industrial Waste Haulers. Alsip, Illinois
 View of tank and drums along the north border of the site.
 OVA reading of 65 units recorded near blue tank in foreground.
 Date: 3-10-89 Time: 1305
 Photographer: Paul Szewczykowski P.S.
 Camera/Film: 35mm/ 200 ASA

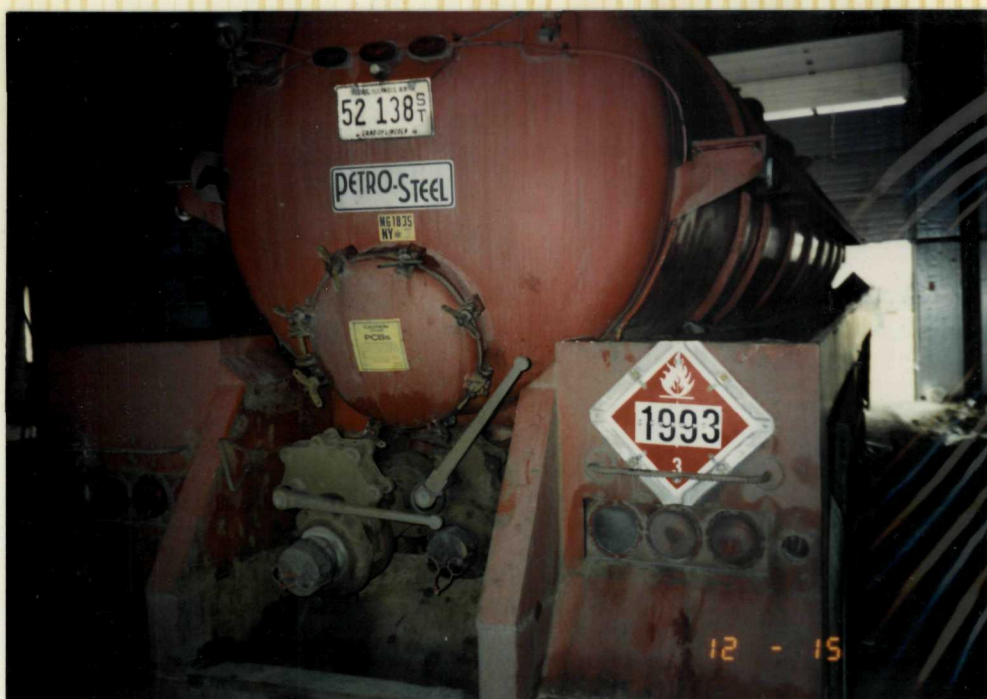
Photograph #9
 Chicago Industrial Waste Haulers. Alsip, Illinois
 View of truck tanker inside on site building. Sampling location
 S-80. Note PCB lable on tanker.
 Date: 3-17-89 Time: 1200
 Photographer: Paul Szewczykowsk *P.S.*
 Camera/Film: 35mm/ 200 ASA

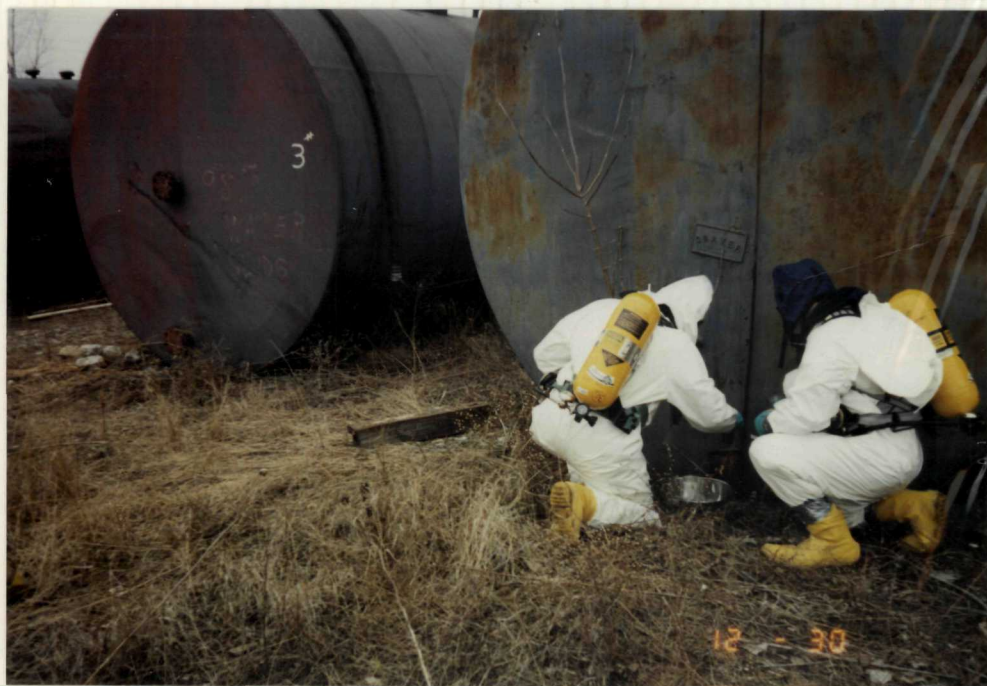
Photograph #10
 Chicago Industrial Waste Haulers. Alsip, Illinois
 TAT collecting samples at tank sampling location S-81.
 Looking west.
 Date: 3-17-89 Time: 1230
 Photographer by: Paul Szewczykowsk *P.S.*
 Camera/Film: 35mm/ 200 ASA

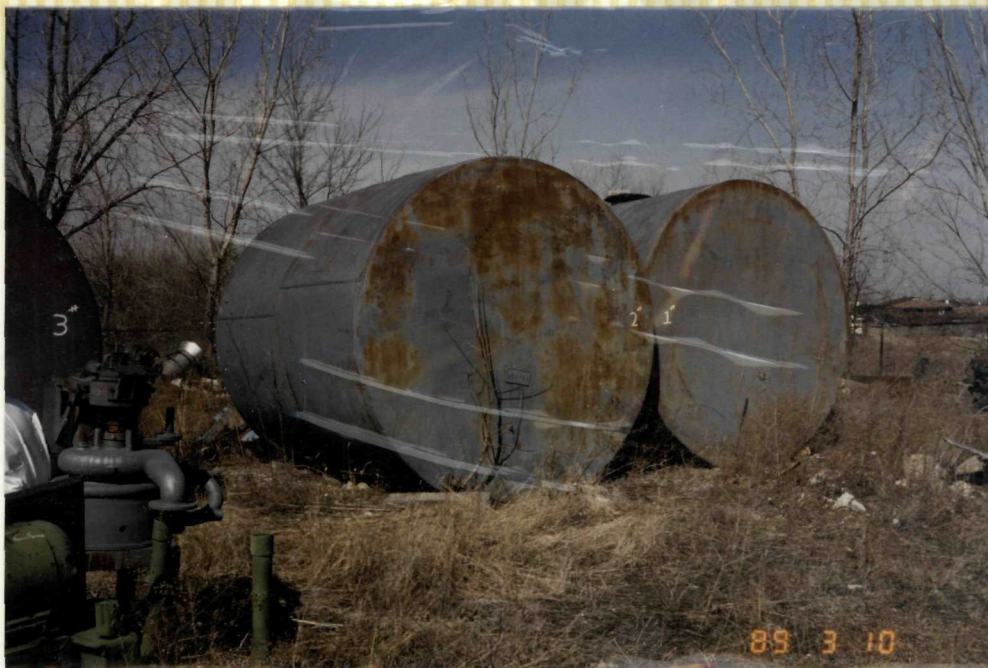
Photograph #11
 Chicago Industrial Waste Haulers. Alsip, Illinois
 Tank labled "1#" was TAT sampling location S-82 on 3-17-89.
 Date: 3-10-89 Time: 1230
 Photographer: Paul Szewczykowsk *PS.*
 Camera/Film 35/ 200 ASP

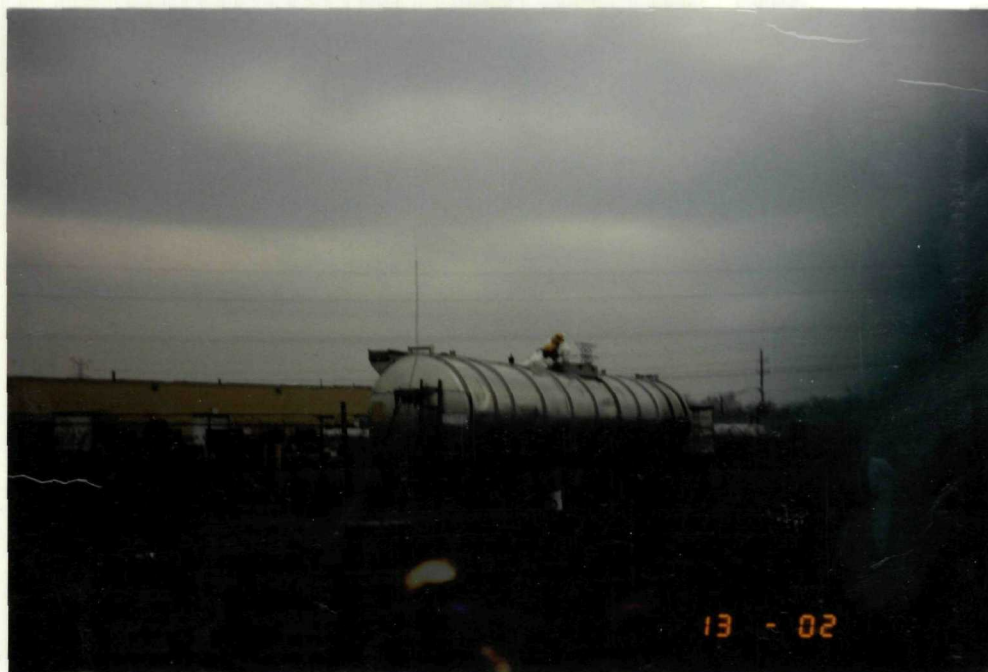
Photograph #12
 Chicago Industial Waste Haulers. Alsip, Illinois
 View of TAT sampling location S-83. Looking south.
 Date: 3-17-89 Time: 1302
 Photographer: Paul Szewczykowsk *PS.*
 Camera/Film: 35mm/ 200 ASA

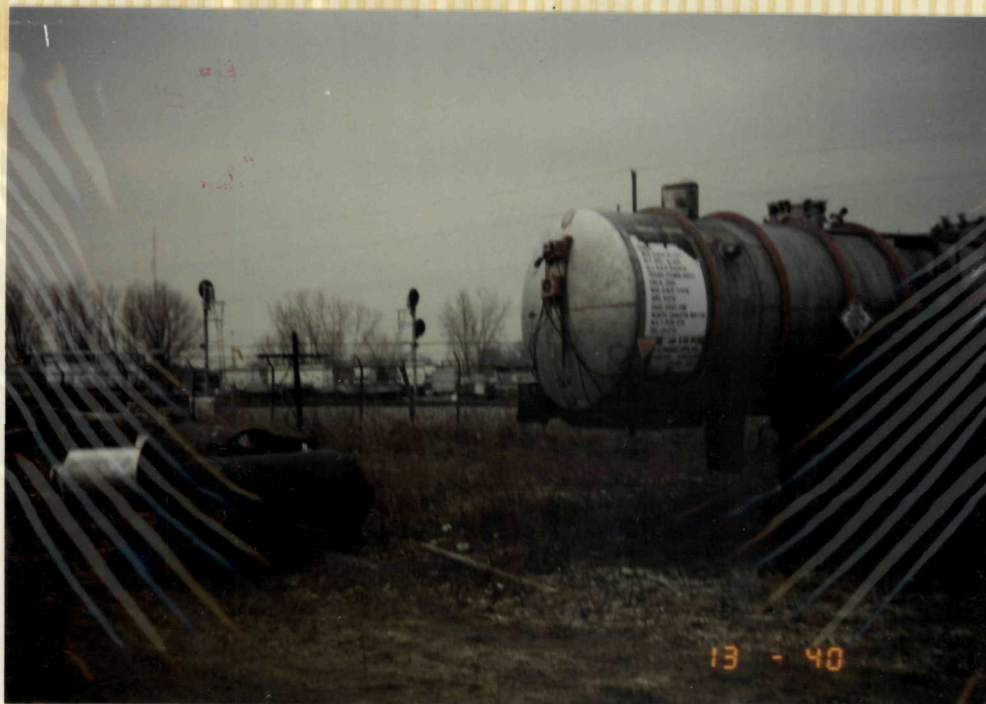
Photograph #13
 Chicago Industrial Waste Haulers. Alsip, Illinois
 View of TAT sampling location S-84.
 Note small horizontal tank where samples were collected.
 Looking south.
 Date: 3-17-89 Time: 1340
 Photographer: Paul Szewczykowski P.S.
 Camera/Film: 35mm/ 200 ASA

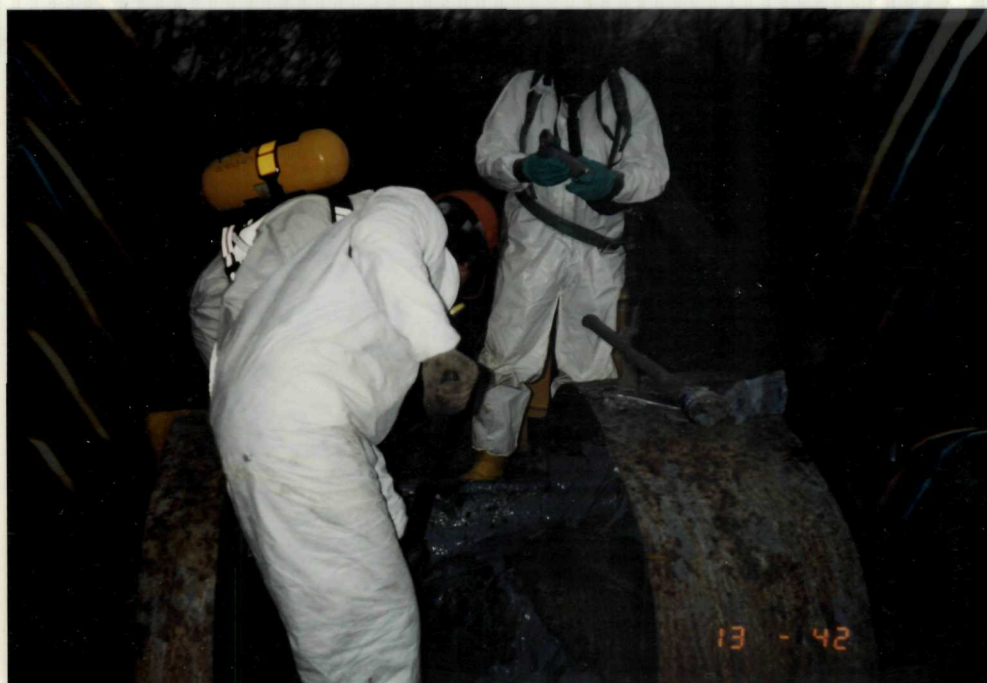
Photograph #14
 Chicago Industrial Waste Haulers. Alsip, Illinois
 View of TAT sampling at sample location S-85.
 Looking north. Note in foreground PRP personnel.
 Date: 3-17-89 Time: 1342
 Photographer: Paul Szewczykowski P.S.
 Camera/Film: 35mm/ 200 ASA

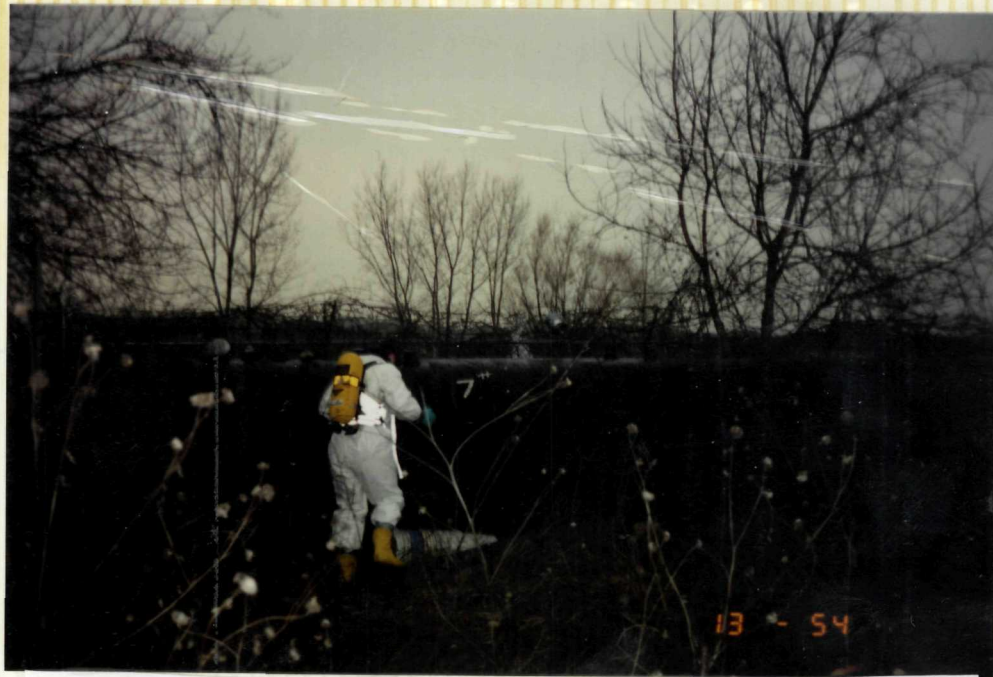
Photograph #15
 Chicago Industrial Waste Haulers. Alsip, Illinois
 View of sampling location S-86; looking north.
 Date: 3-17-89 Time: 1354
 Photographer: Paul Szewczykowski P.S.
 Camera/Film: 35mm/ 200 ASA

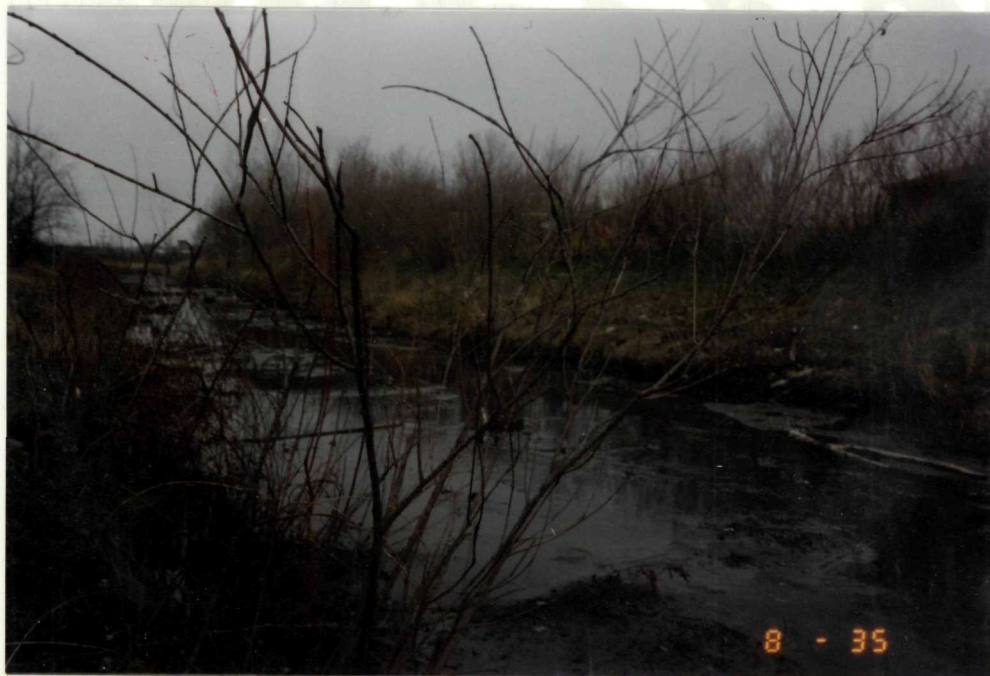
Stony Creek, a natural waterway, is located less than 150 feet north of the site. Although no hydrogeologic data has been obtained, the elevation of Stony Creek suggests the presence of the water table within ten feet of the surface. Discoloration of the soil near many of the tanks on-site suggests the possibility that contaminants may have penetrated into the underlying aquifer. If contamination of the aquifer has occurred, the nearest downgradient surface water, Stony Creek, may be at risk. Stony Creek is a tributary to the Calumet Sag Channel. Water from the Sag Channel eventually drains to larger river systems upon which several communities rely for drinking water supplies. These water supplies could be threatened. Also, the aquatic ecosystems of these rivers could be damaged.

Photograph #16
 Chicago Industrial Waste Haulers. Alsip, Illinois
 Looking at Stony Creek where it flows adjacent and
 north of the site. Looking northwest and upstream.
 Date: 4-14-89 Time: 0835
 Photographer: Paul Szewczykowski P.S.
 Camera/Film: 35mm/ 200 ASA

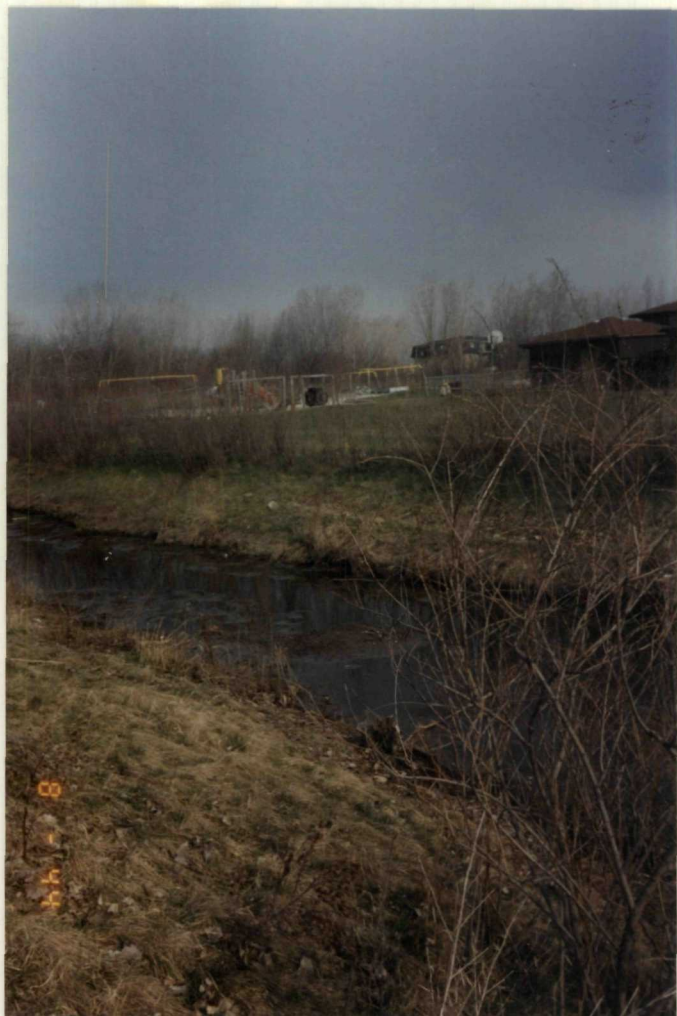
Photograph #17
Chicago Industrial Waste Haulers. Alsip, Illinois
View of playground located north of the site and Stony Creek.
Date: 4-14-89 Time: 0844
Photographer: Paul Szewczykowski P.S.
Camera/Film: 35mm/ 200 ASA

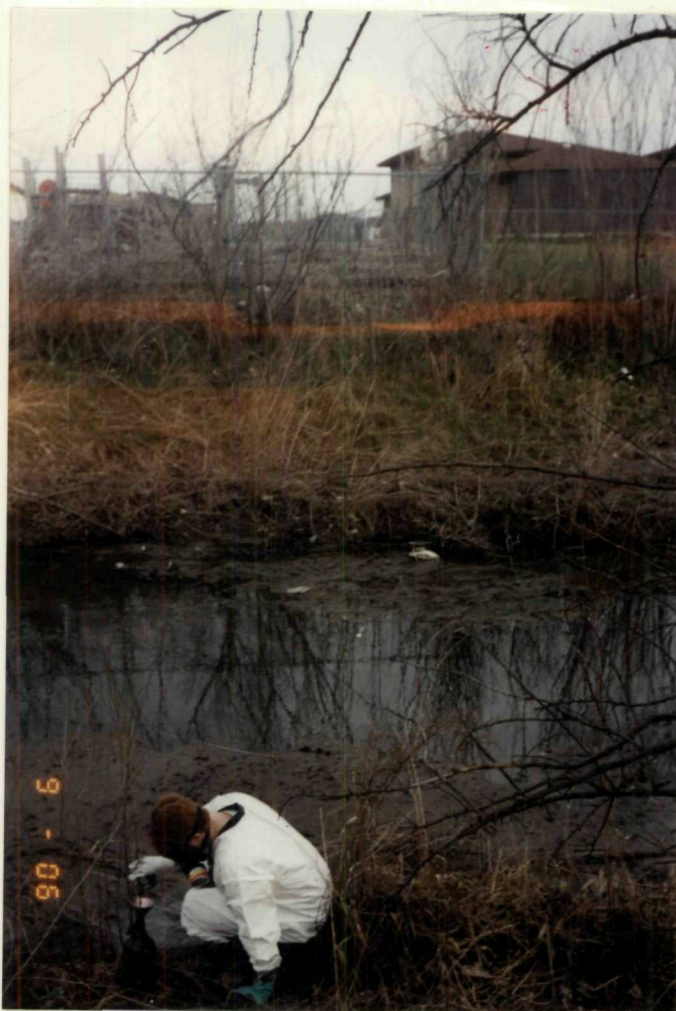
Photograph #18
Chicago Industrial Waste Haulers. Alsip, Illinois
View of TAT collecting surface water samples at sampling
location S-25.
Note playground in background.
Date: 4-14-89 Time: 0906
Photographer: Paul Szewczykowski P.S.
Camera/Film: 35mm/ 200 ASA

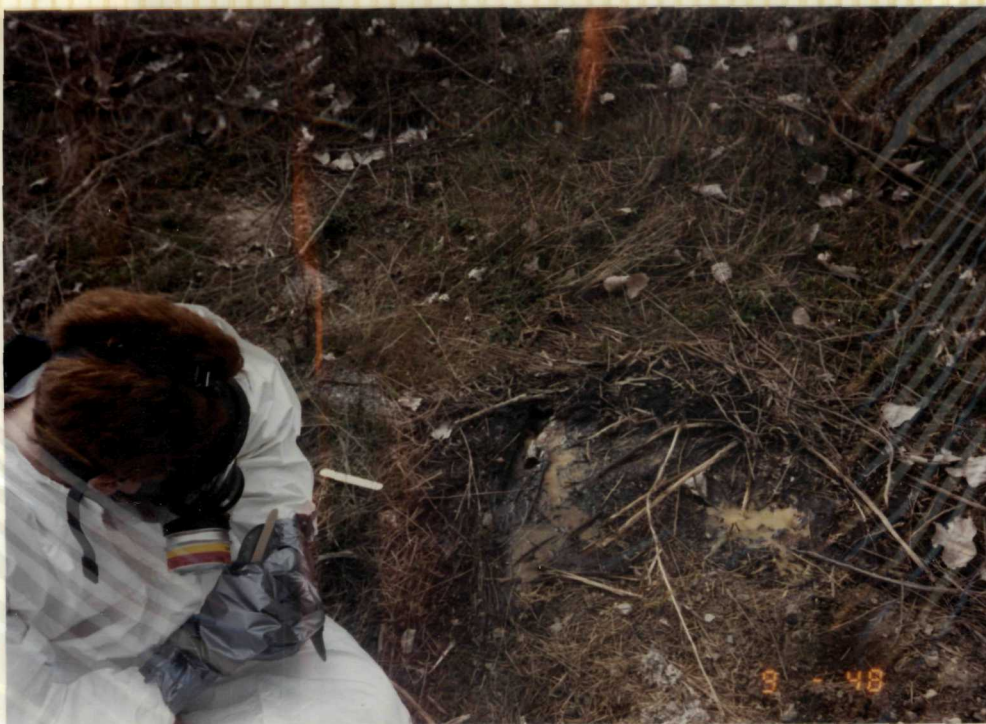
Photograph #19
 Chicago Industrial Waste Haulers. Alsip, Illinois
 View of TAT collecting soil samples at sample location S-27.
 Date: 4-14-89 Time: 0948
 Photographer: Paul Szewczykowski *PS.*
 Camera/Film: 35mm/ 200 ASA

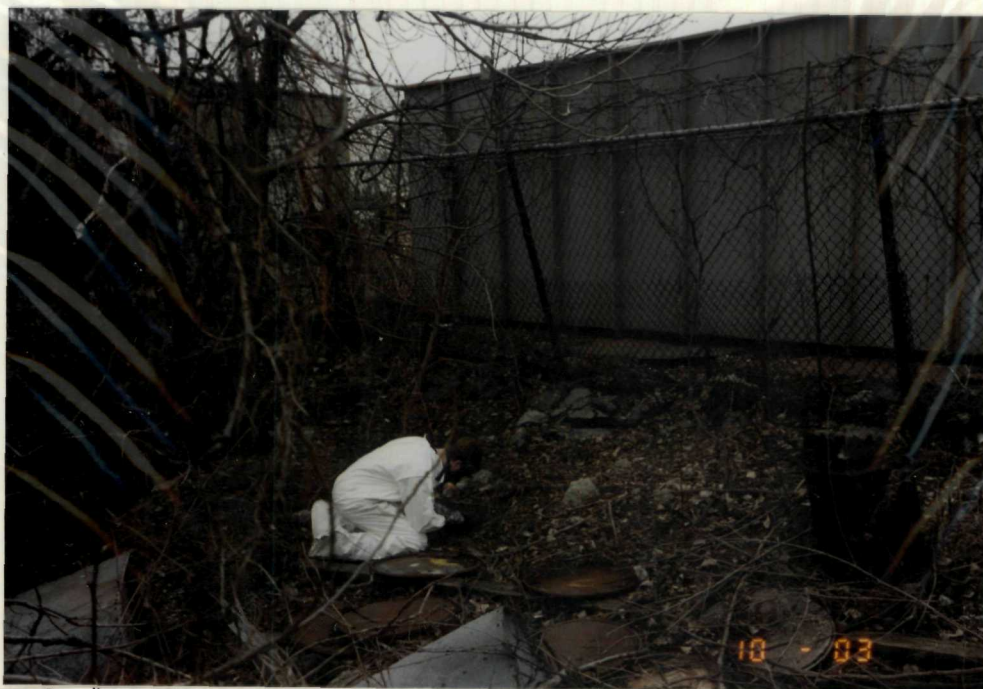
Sampling of the vacant lot adjacent to the site has indicated the presence of PCB contamination in surface soils. The lot was observed to contain drums and metal debris strewn throughout. Access to the lot is not restricted and is less than 100 feet from the playground and residential areas. Direct contact exposure to PCB-contaminated soil is likely.

Photograph #20
 Chicago Industrial Waste Haulers. Alsip, Illinois
 View of TAT collecting samples at soil sampling location
 S-28. Note deteriorated drum and drum lids scattered around the area.
 Date: 4-14-89 Time: 1003
 Photographed by: Paul Szewczykowski *PS.*
 Camera/Film: 35mm/ 200 ASA

- o An extent of contamination study could be conducted on the site and vacant lot soils, and in Stony Creek sediments.
- o Based on soil and sediment sampling results, soils and sediments contaminated with PCBs, metals, solvents or other contaminants, above cleanup standards, could be excavated and disposed of or treated in compliance with RCRA regulations.

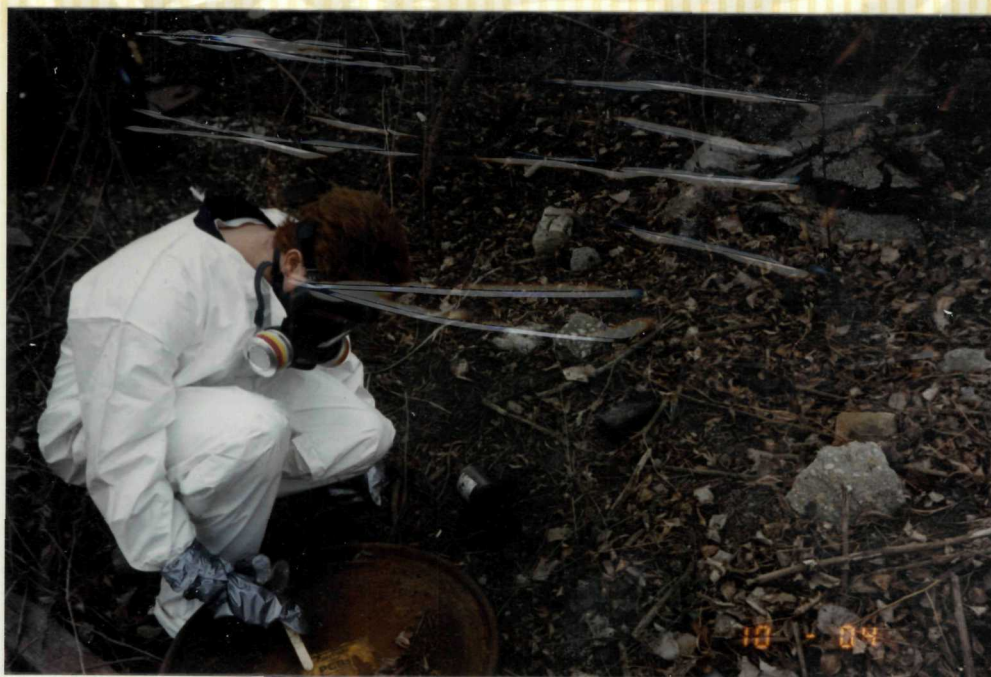
Photograph #21
 Chicago Industrial Waste Haulers. Alsip, Illinois
 View of drum lid with PCB lable at sampling location S-28.
 Date: 4-14-89 Time: 1004
 Photographer: Paul Szewczykowski P.S.
 Camera/Film: 35mm/ 200 ASA

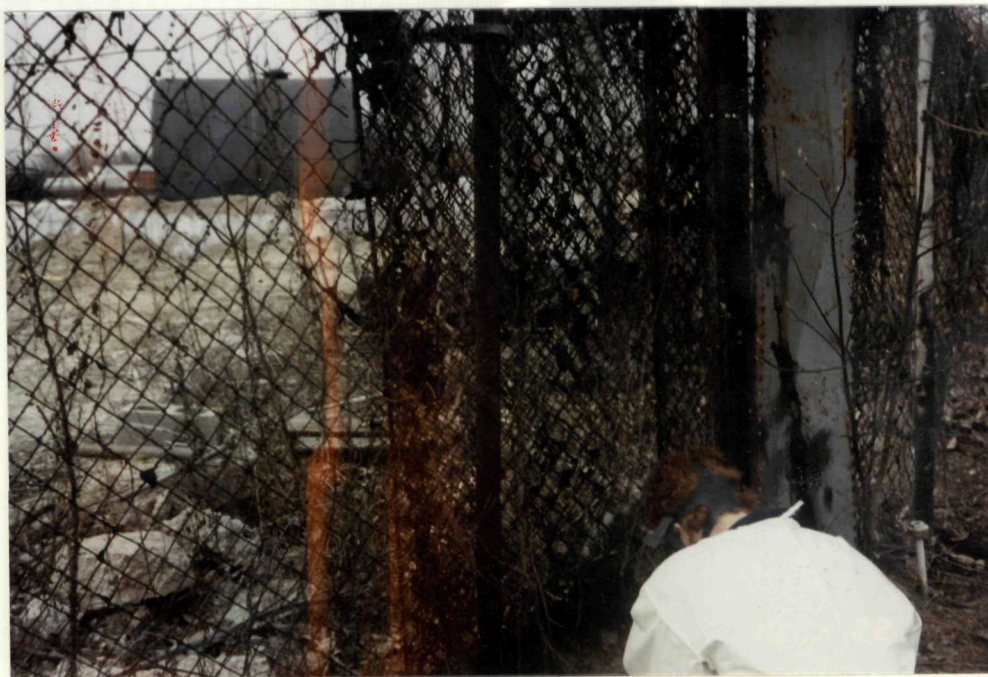
Photograph #22
 Chicago Industrial Waste Haulers. Alsip, Illinois
 View of TAT sampling at soil locations S-29, and S-30.
 Looking southwest.
 Date 4-14-89 Time: 1022
 Photographer: Paul Szewczykowski P.S.
 Camera/Film: 35mm/ 200 ASA

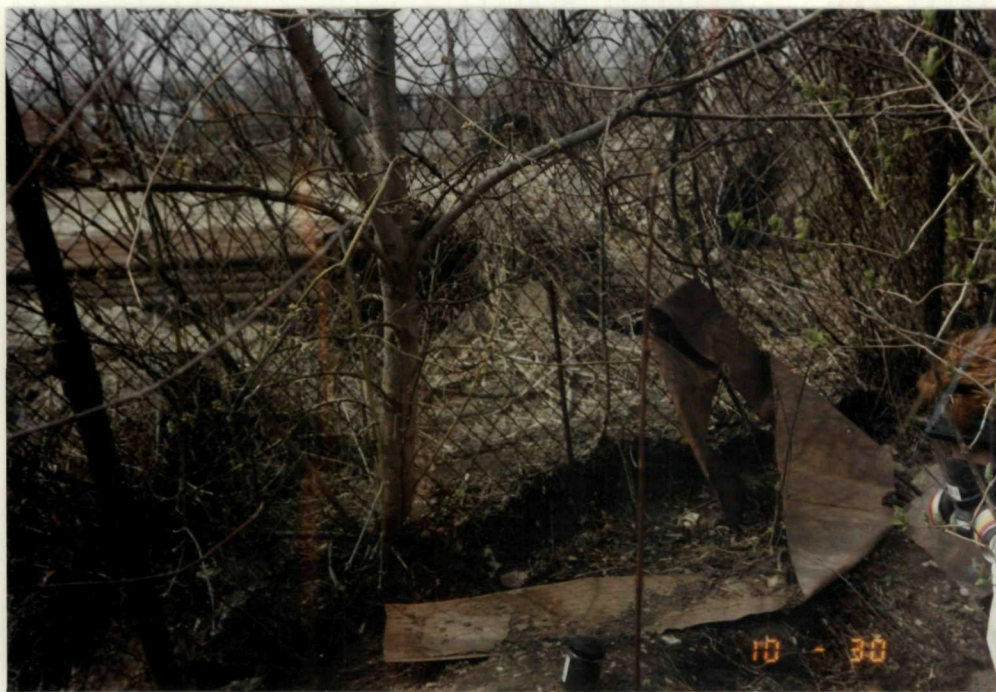
Photograph #23
Chicago Industrial Waste Haulers. Alsip, Illinois
View of soil sampling location S-31. Looking southeast.
Date: 4-14-89 Time: 1030
Photographer: Paul Szewczykowsk *PS*
Camera/Film: 35mm/ 200 ASA

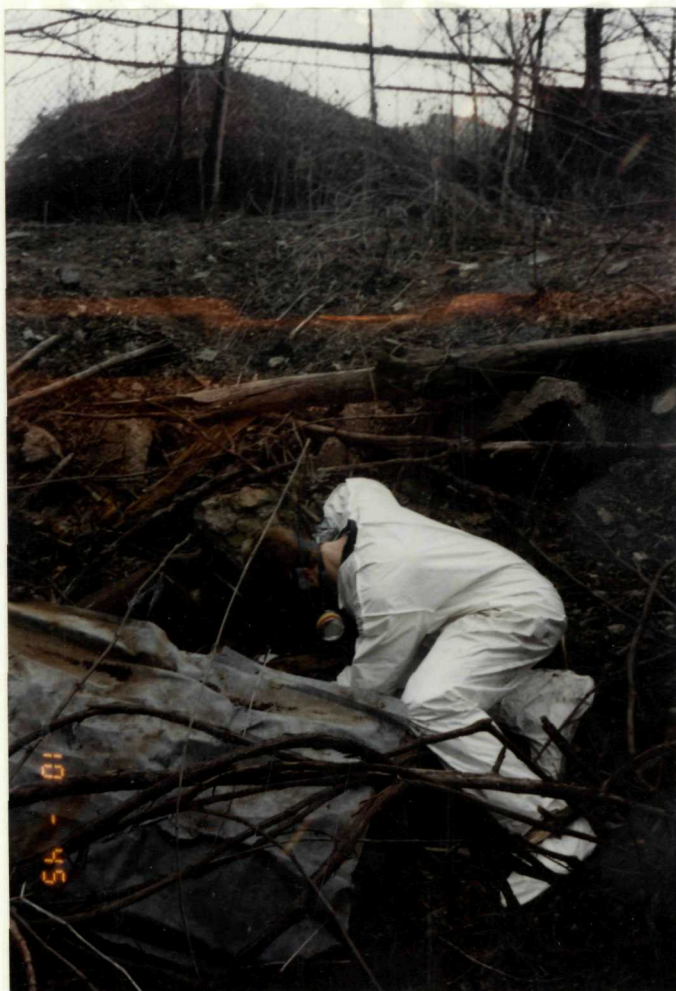
Photograph #24
Chicago Industrial Waste Haulers. Alsip, Illinois
View of TAT collecting a soil sample from sample location
S-32. Looking southeast.
Date: 4-14-89 Time: 1045
Photographer: Paul Szewczykowski P.S.
Camera/Film: 35mm/ 200 ASA
